# The Practices of Preserving Medieval Castles in Latvia from 1945 to 1991: The Case of Turaida Castle

Ieva Ose

Turaida Museum Reserve, Turaidas iela 10, Siguldas novads, LV-2150 Sigulda, Latvia; ieva.ose@tmr.gov.lv

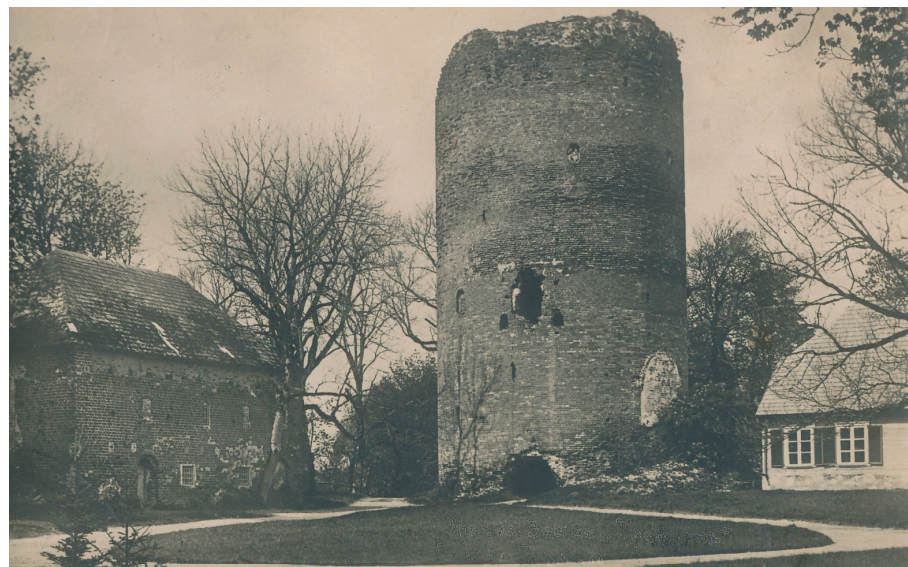
**Figure 2.** The main courtyard of the Turaida Castle ruins: the Main Tower in the center, the west block on the left, the 18th century wooden building on the right; photo on the early 20th-century postcard (TMR, Sm 5351).

roofless, with collapsed upper walls and loss of the intermediate floors; only fragments of internal staircases survived (Figure 2). The west block remained the sole roofed structure, serving as a storehouse, while most of the other walls, towers, and buildings had collapsed to ground level and were covered by debris [22].

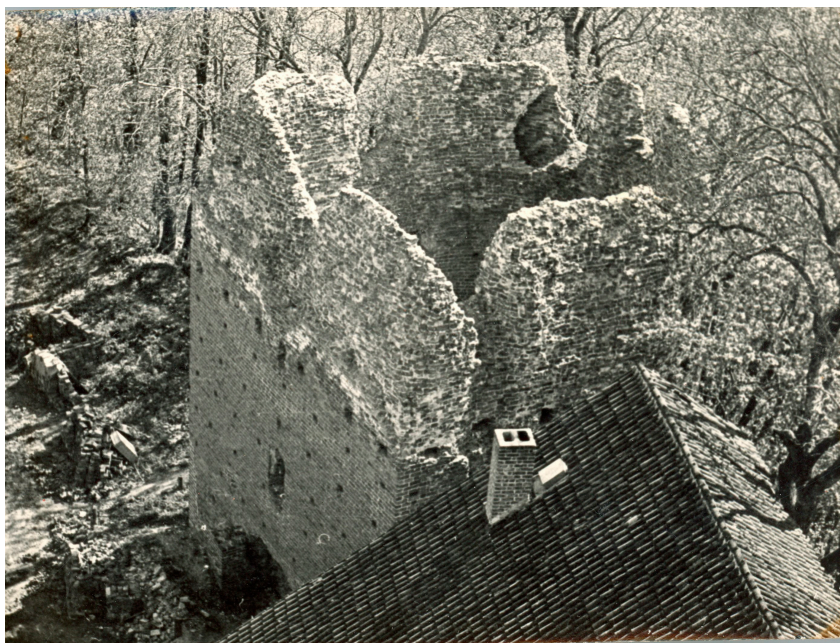
**Figure 4.** (a) Ruins of the west tower, photo ca. 1955 [38]. (b) Rejected conservation project for the west tower [39].

The NHB archive preserves a 1962 conservation project for the west tower prepared by architect Gunārs Zirnis [30]. At that time, urgent measures were necessary to prevent accidents, as the ruins posed a danger to visitors due to falling bricks from the collapsing façade and upper floors (Figure 4a). The project included filling wall gaps, restoring collapsed openings, and covering the top of the ruins with a concrete layer. In 1963, a sketch plan for the main courtyard was drafted, proposing conservation of the ruins of the enclosing wall and indicating the layout of the former east and north residential blocks by means of rows of concrete slabs [31]. These plans were not implemented.
